Subject: **April 2012 Compliance Evaluation Inspection**

**CWA COMPLIANCE EVALUATION INSPECTION REPORT  
U.S. ENVIRONMENTAL PROTECTION AGENCY, REGION 5**

L'Anse Warden Electric Company  
John H. Warden Station  
157 South Main Street  
L'Anse, Michigan 49946  
46.755555, -88.455555

MI0006092

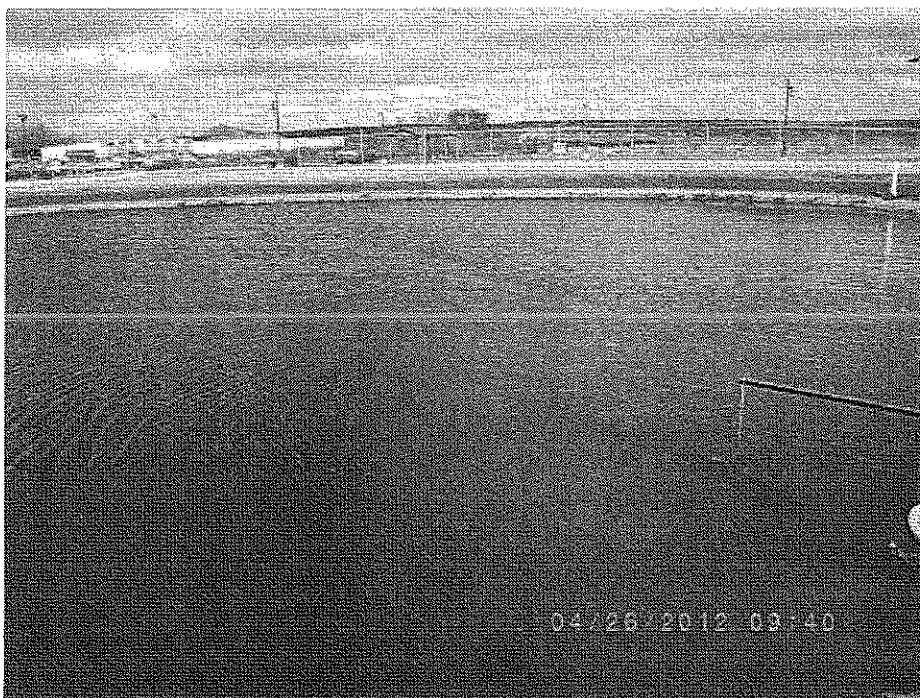
Photo IMGP0924: Effluent pond 3, note the ash colored discharge from the submerged pipe.  
Direction: Facing northwest.

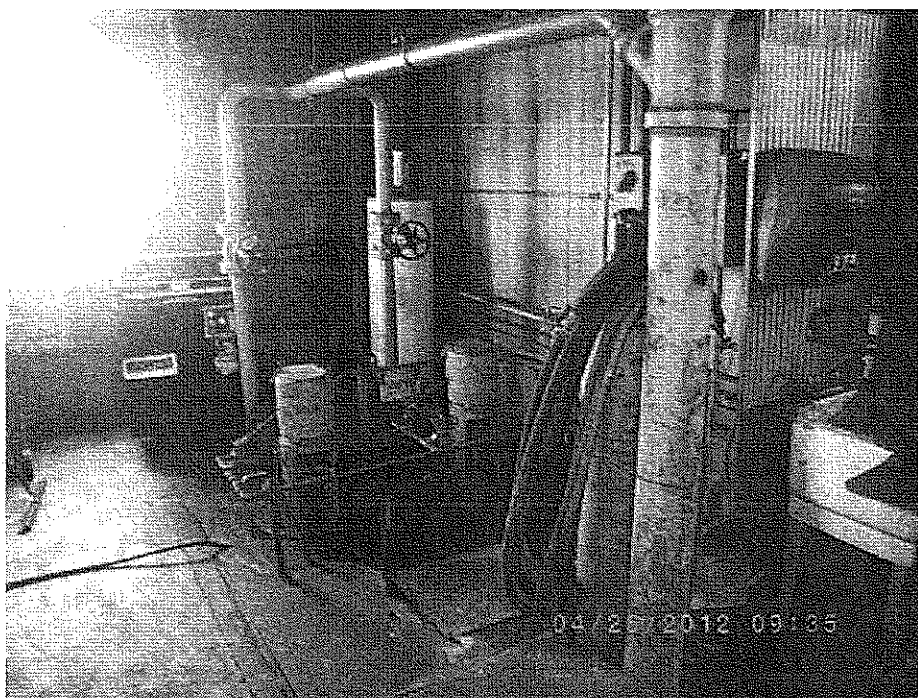
Photo IMGP0921: Sump inside of the generating station that discharges to effluent pond 3.  
Direction: Facing north.

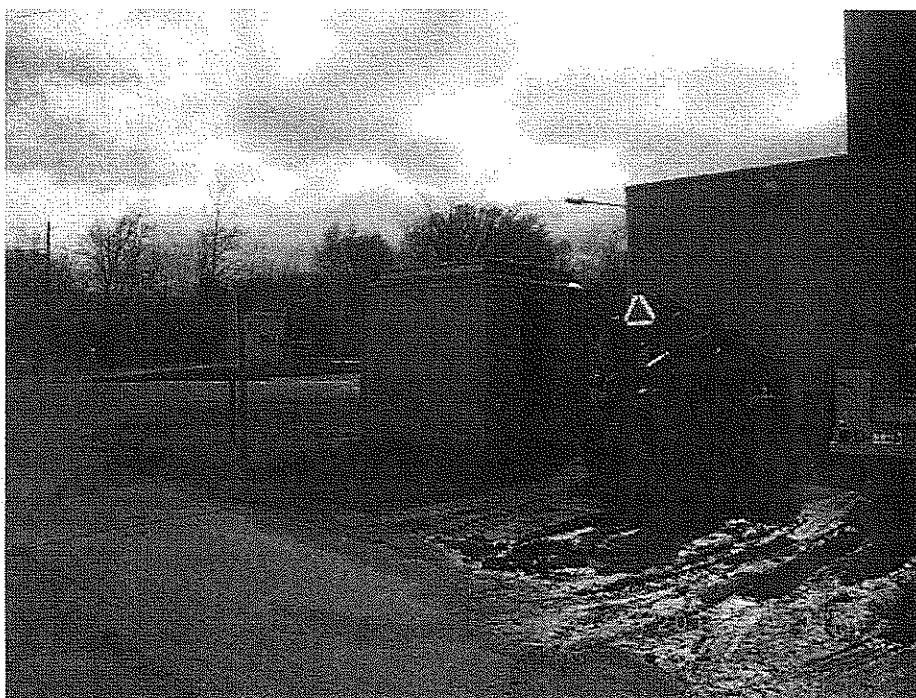
Photo IMGP0923: Effluent pump house on the north side of the generating station.  
Direction: Facing east.

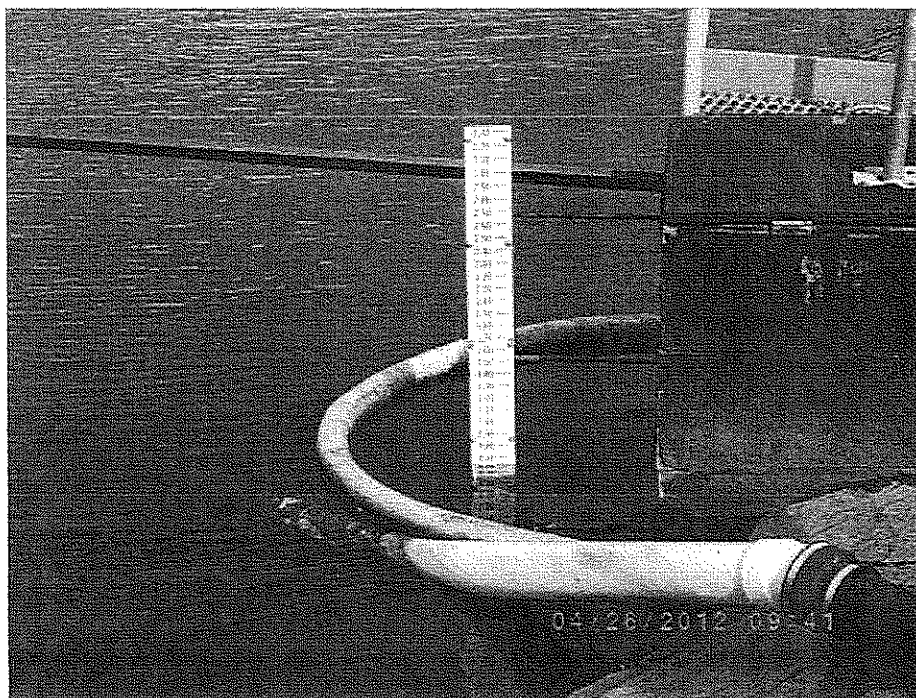
Photo IMGP0925: Effluent pond 3 discharge point and staff gauge used to determine discharge volume.  
This is also the sampling point for outfall 002.  
Direction: Facing north.

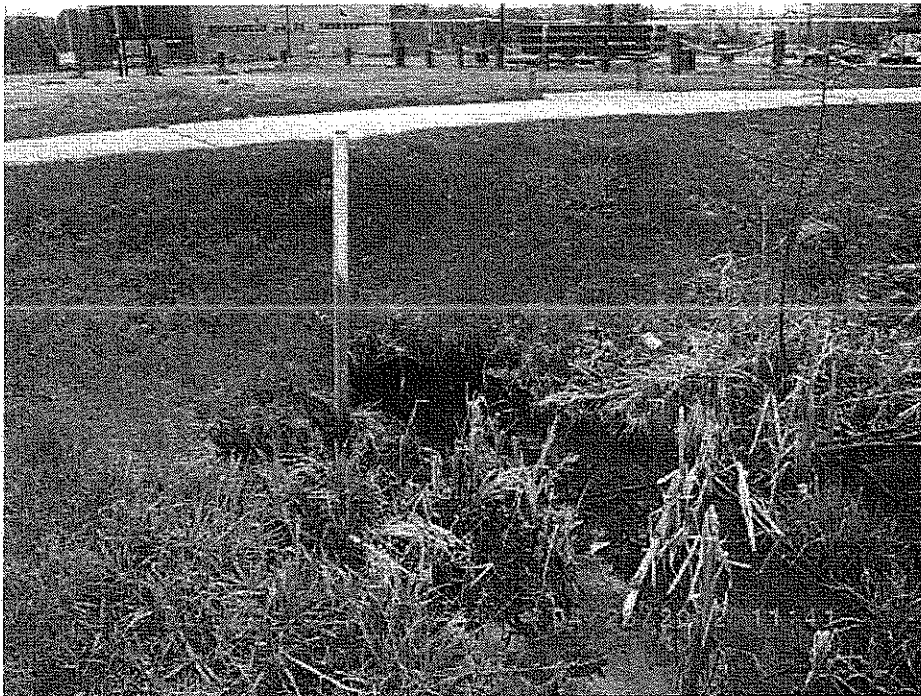
Photo IMGP0971: Discharge culvert from outfall 002 into Keweenaw Bay, Lake Superior. Note the generating station, the grey building, in the background.  
Direction: Facing southeast.

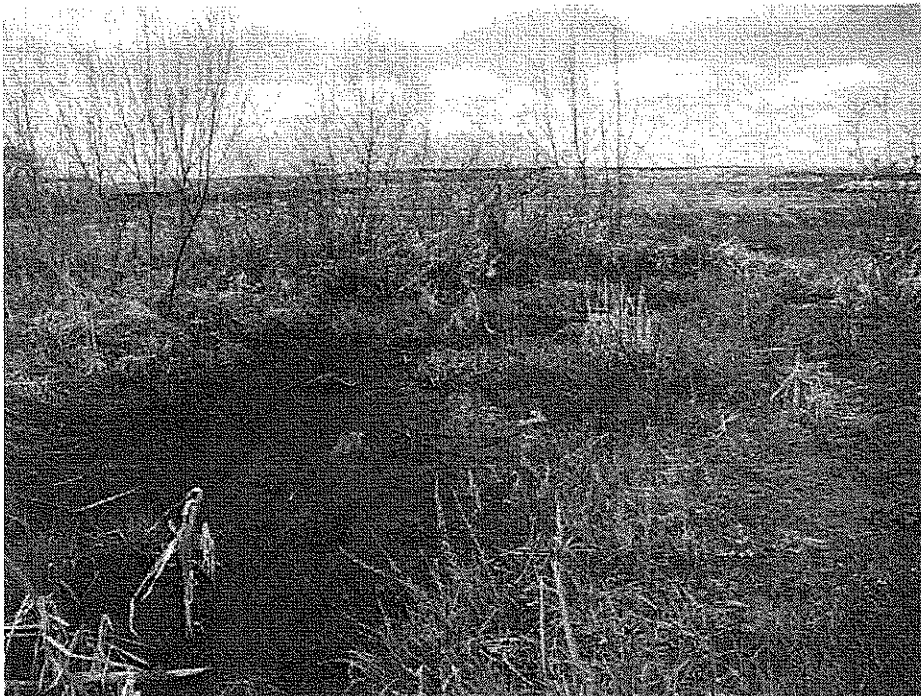
Photo IMGP0972: Discharge pathway from outfall 002 into Keweenaw Bay, Lake Superior.  
Direction: Facing northwest.

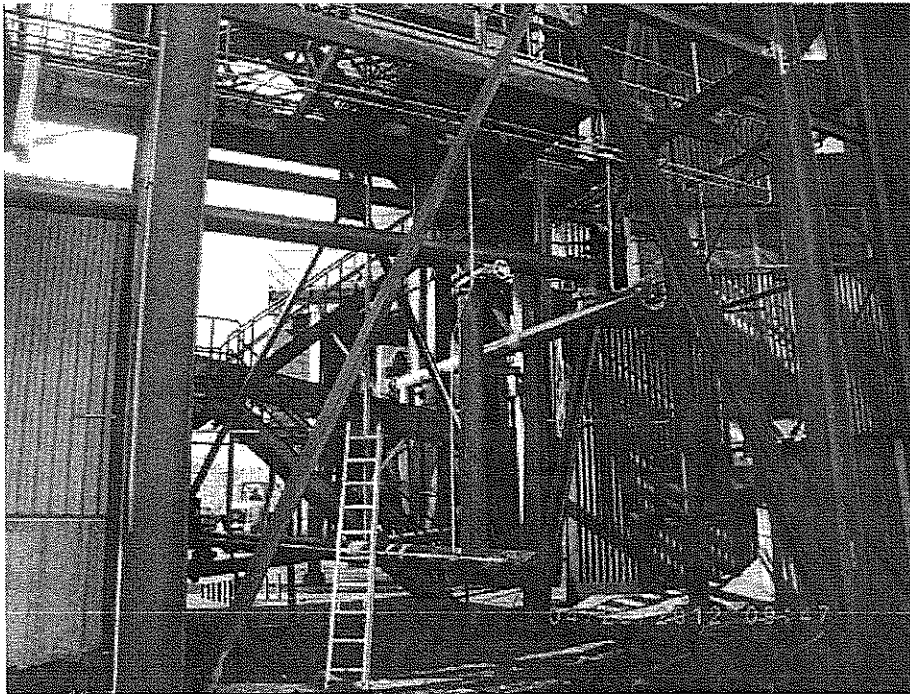
Photo IMGP0926: Ash handling system that used a screw auger piping system to move wetted bottom and fly ash from to the ash storage building.  
Direction: Facing west.

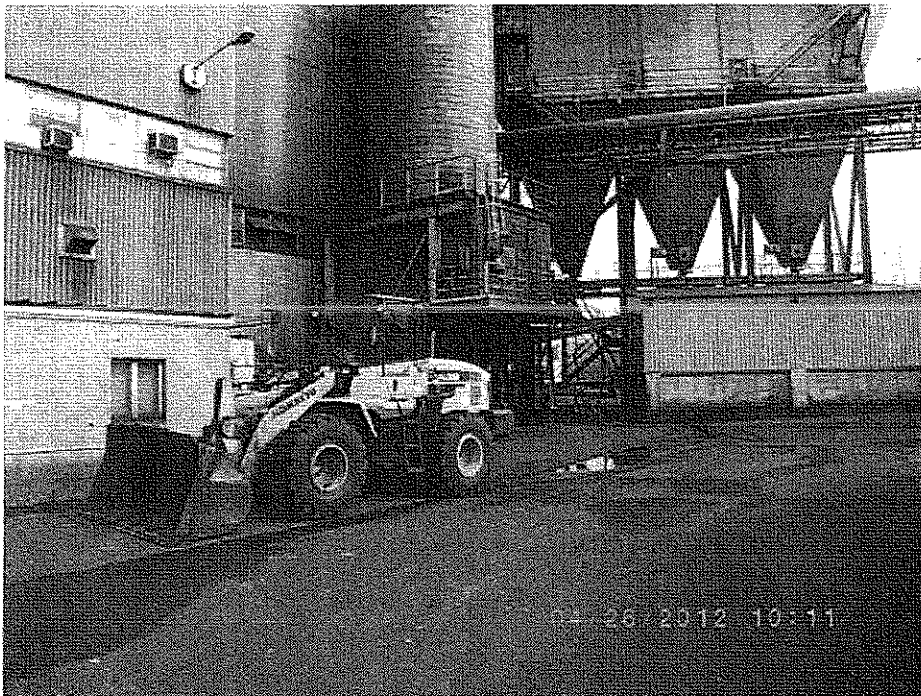
Photo IMGP0942: Front end loader used to transfer ash with the ash storage building in the background.  
Direction: Facing northeast.

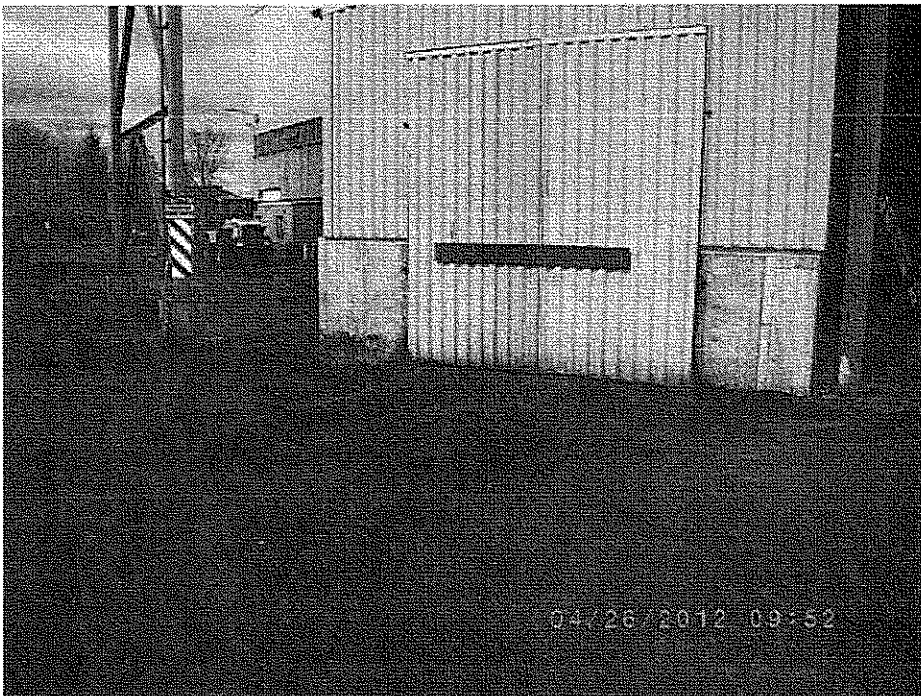
Photo IMGP0929: Ash that had been tracked and spilled on the asphalt outside of the ash storage building.  
Direction: Facing west.

3. Section 4.0(G), and 7.0(E)(1) of the SWPPP state that ash and solid biomass spills identified would be cleaned up swiftly. This is not consistent with the ash (Photo IMGP0929) and wood fines (Photo IMGP 0935) that I observed on the day of the inspection.

Continued implementation of the current SWPPP will help to mitigate storm water contamination and runoff from JHWS. Good housekeeping practices including sweeping should be done as needed, which may be multiple times daily around areas such as the

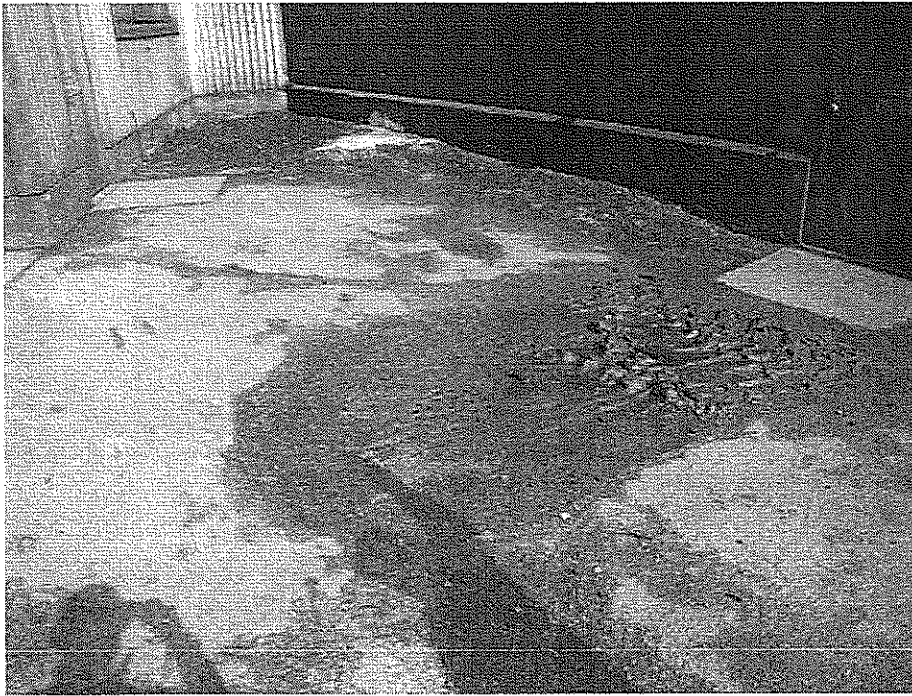
entire east side of the generating station including the ash handling and transport areas, old ash storage area, and the paved area between the generating station and the maintenance building (Appendix I). This catch basin discharges into effluent pond 3. The catch basin was surrounded by solids, including what I observed as ash (Photo IMGP0927). The area around the catch basin, which included the old ash storage area (Photo IMGP0928), contained particulate debris.

Photo IMGP0927: Catch basin on the northeast side of the generating station that discharges to effluent pond 3.

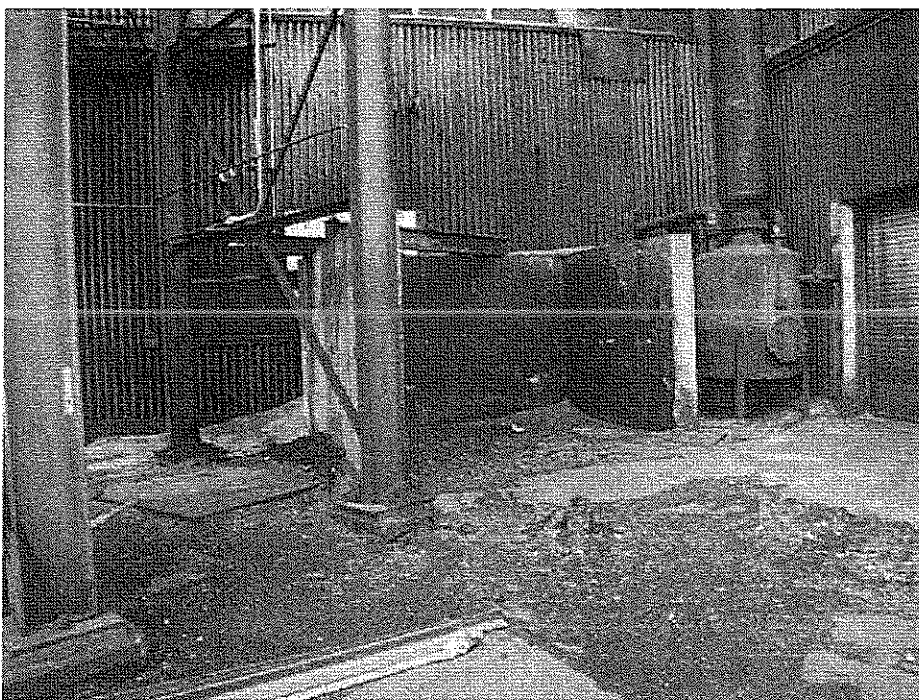
Photo IMGP0928: Old ash storage area on the northeast side of the generating station. The old ash storage area is adjacent to the storm water catch basin that discharges into effluent pond 3.  
Direction: Facing west.

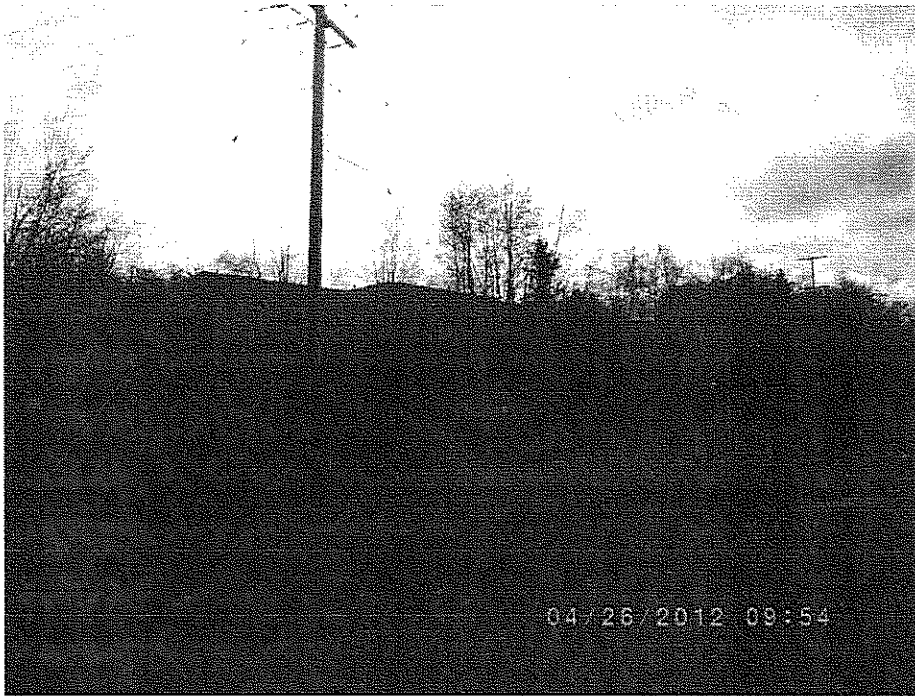
I observed that there was a large berm along the northeast side of the facility. Darryl Koski stated that the berm was an old railroad line (Photo IMGP0930). The berm was greater than 20 feet in height and would prevent any runoff from leaving JHWS to the northeast.

Photo IMGP0930: Berm along the northeast side of JHWS that is a former railroad line.  
Direction: Facing east.

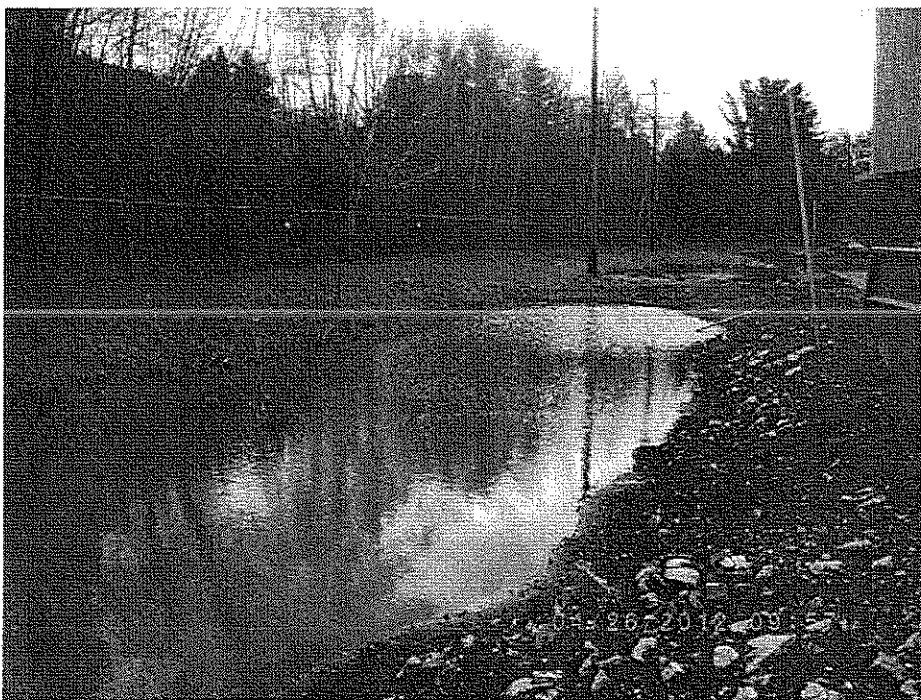
Photo IMGP0932: Storm water pond 2 which includes two retention ponds along the northeast side of JHWS.

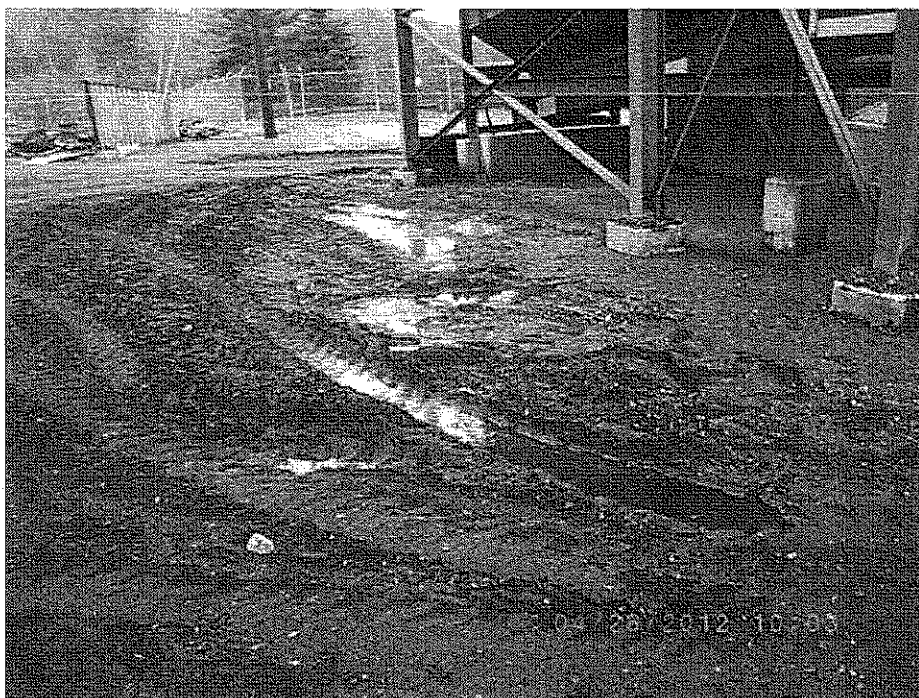
Photo IMGP0936: Flow path for potential overflows from storm water pond 2.

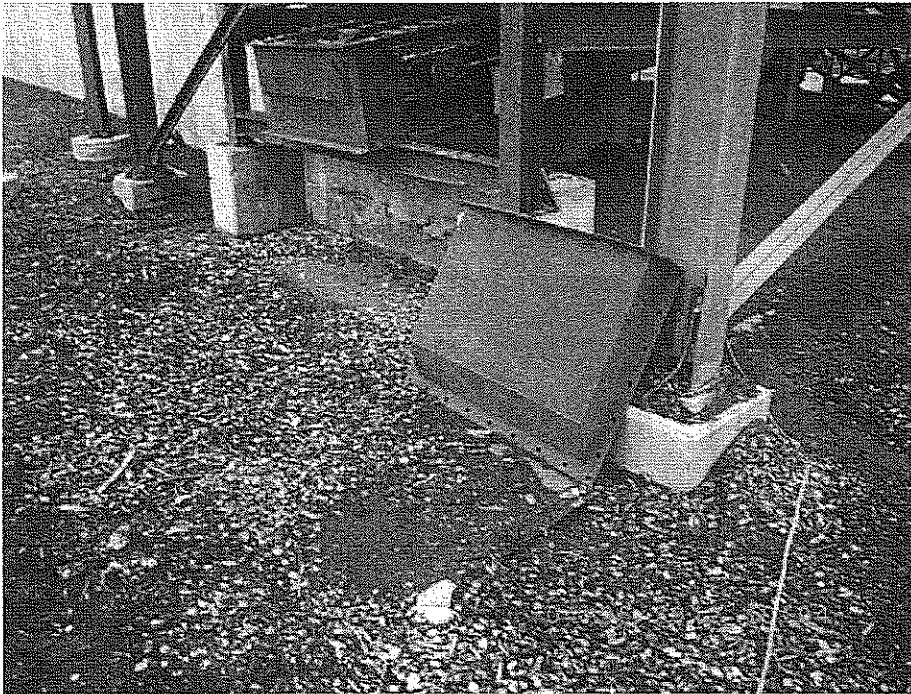
Photo IMGP0937: Culvert inlet (Note the inlet in the front center of the photo covered by a metal sheet and located at the base of the blue metal cover on the ground.) adjacent to the receiving hopper leading to storm water pond 1.

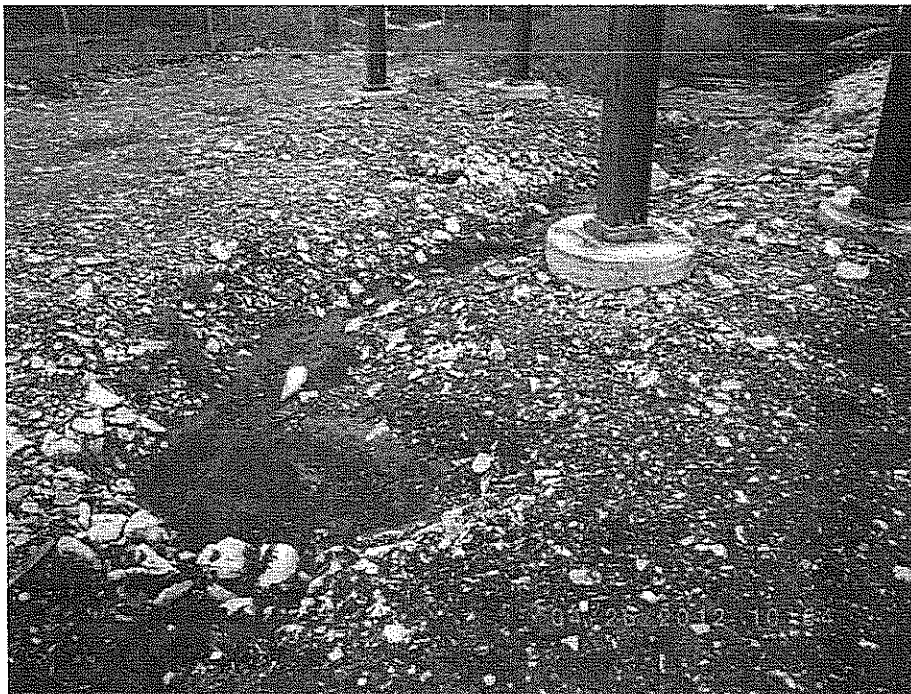
Photo IMGP0938: Culvert outlet and ditch leading to storm water pond 1 in the background.

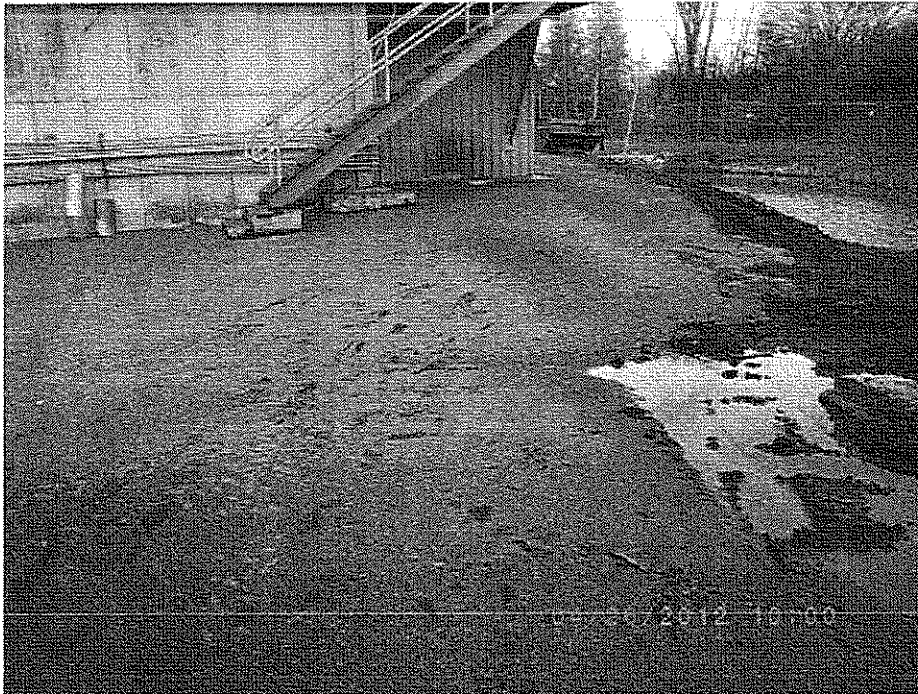
Storm water pond 2 receives storm water flow from off of the railroad berm, from the northeast to south side of the biomass fuel storage building and from the area around the receiving hopper and first belt conveyor (Appendix I). I observed that the area under the receiving hopper and first belt conveyor was covered in wood fines (Photo IMGP0935). I observed that wood fines were falling from the first conveyor when I stood on the southwest side of the biomass fuel storage building. The wood fines had accumulated in large piles along the edge of the south storm water pond 2 (Photo IMGP0934).

Photo IMGP0935: Wood fines on the ground underneath the first belt conveyor, note the accumulated piles of wood fines on the right.  
Direction: Facing northwest.

conveyor systems and ash storage building. TDF should be stored where it does not come into direct contact with storm water.

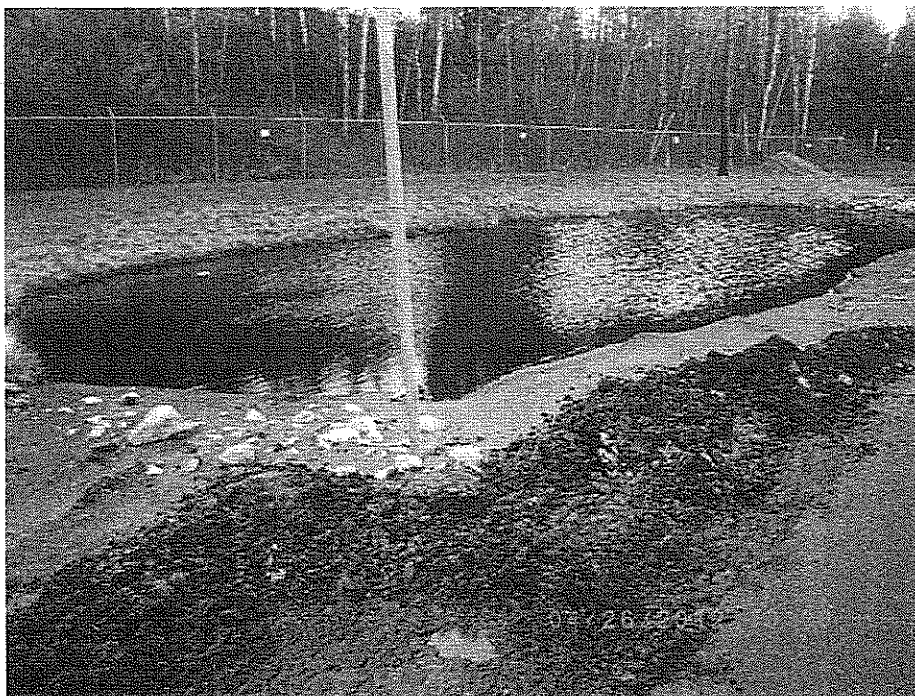
Photo IMGP0934: Accumulated wood fines on the edge of the south storm water pond 2.  
Direction: Facing east.

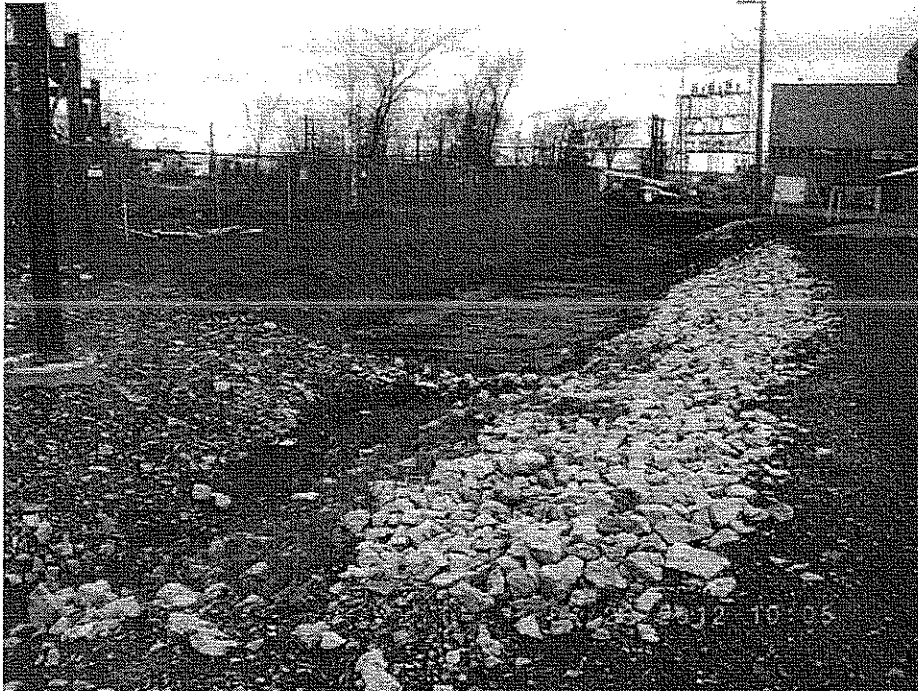
I observed that storm water pond 1 had recently been dredged and contained no water during the inspection (Photo IMGP0939 and IMGP 094040). Darryl Koski stated that storm water pond 1 almost never contains water because of rapid infiltration. He also stated that the pond was recently dredged to remove all of the TDF that was in storm water pond 1. Storm water pond 1 receives flow from the asphalted area around the southwest side of the biomass fuel storage building and some areas under the second belt conveyor (Photo IMGP0933 and Appendix I).

Photo IMGP0939: Storm water pond 1 containing no water and recently dredged.  
Direction: Facing northwest.

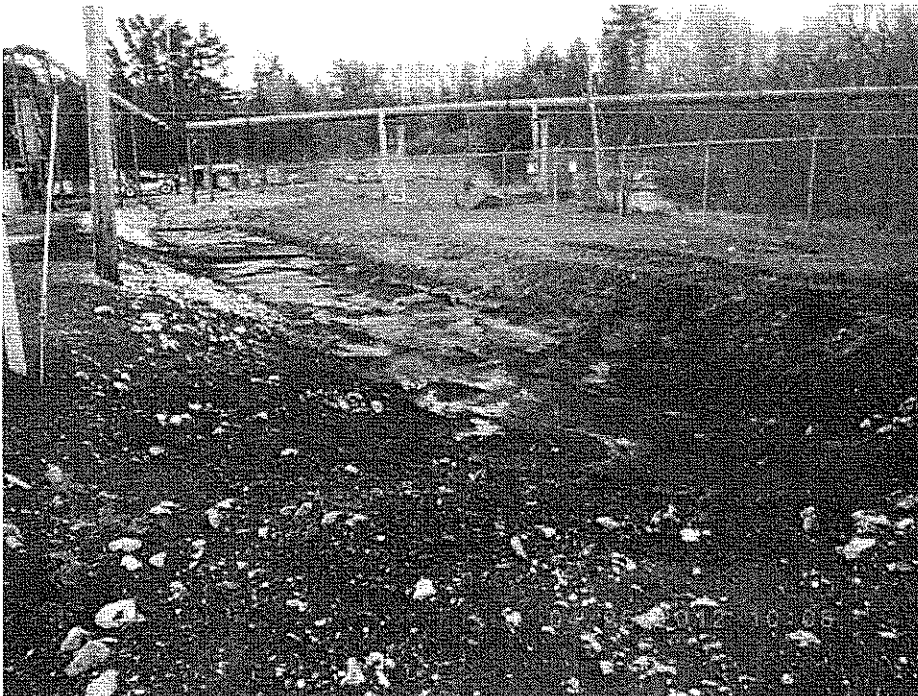
Photo IMGP0940: Storm water pond 1 with the pneumatic conveyor and receiving hopper in the background.  
Direction: Facing southeast.

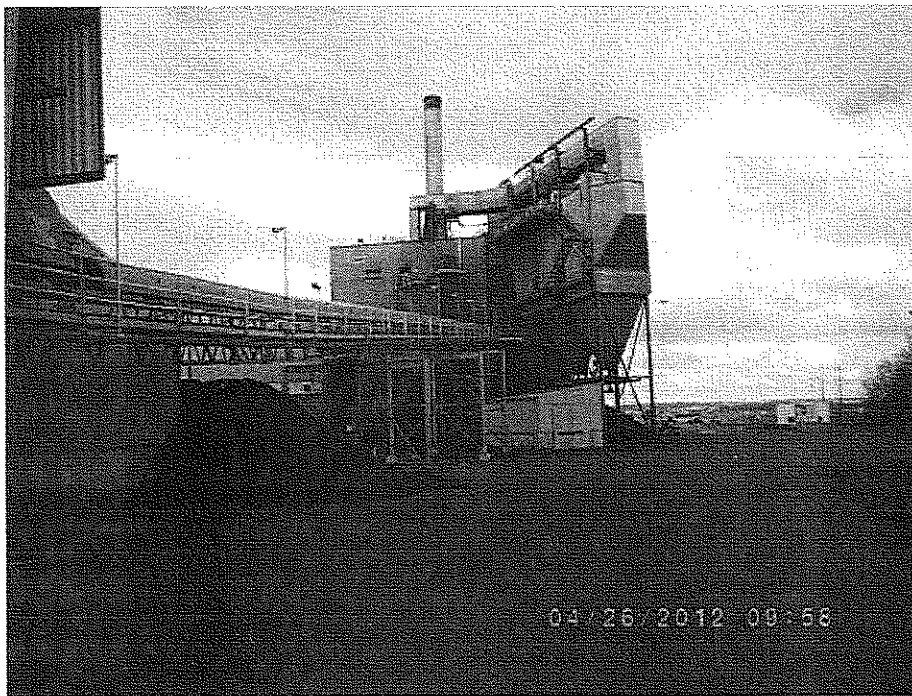
Photo IMGP0933: Second belt conveyor leading to the boiler with the TDF pile underneath.  
Direction: Facing northwest.

TDF was proportionally added to the wood chips at the biomass fuel storage building, where some of the TDF was being stored. I observed that most of the TDF on site was stored in a pile underneath the second belt conveyor on the northwest side of the biomass fuel storage building (Photo IMGP0931 and IMGP0933). Runoff from TDF would flow either to storm water pond 2 or into storm water pond 1.

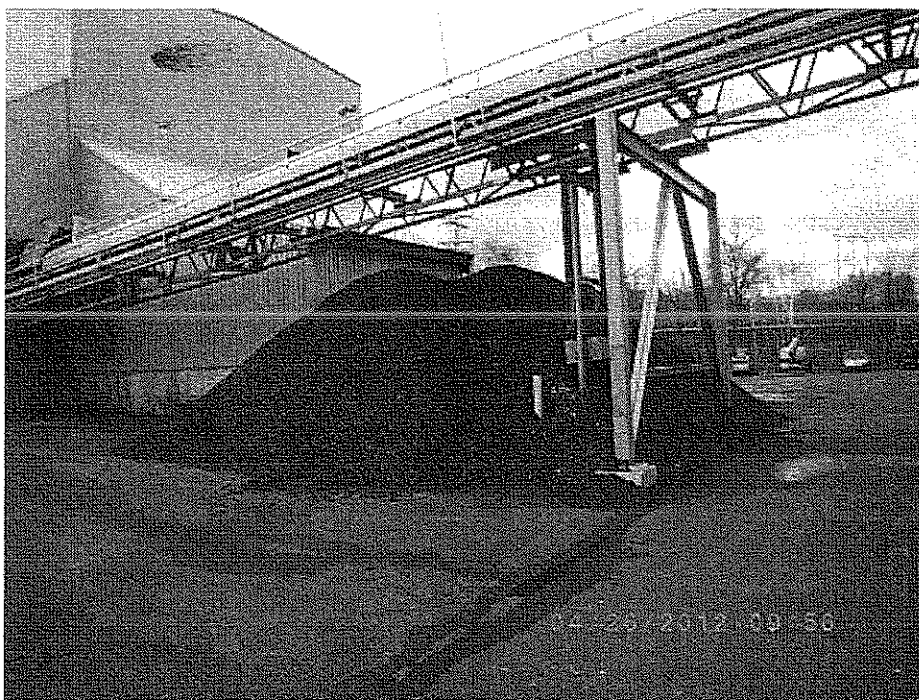
Photo IMGP0931: TDF is stored underneath the second belt conveyor with storm water from the pile flowing both northeast from the front of the pile and southwest from the far side of the pile. Direction: Facing southwest.

4. Section 4.0(G) of the SWPPP states that all solid fuel would not contact storm water unless a spill occurred and was not cleaned up. This is not consistent with the TDF that was stored outside at the time of the inspection.

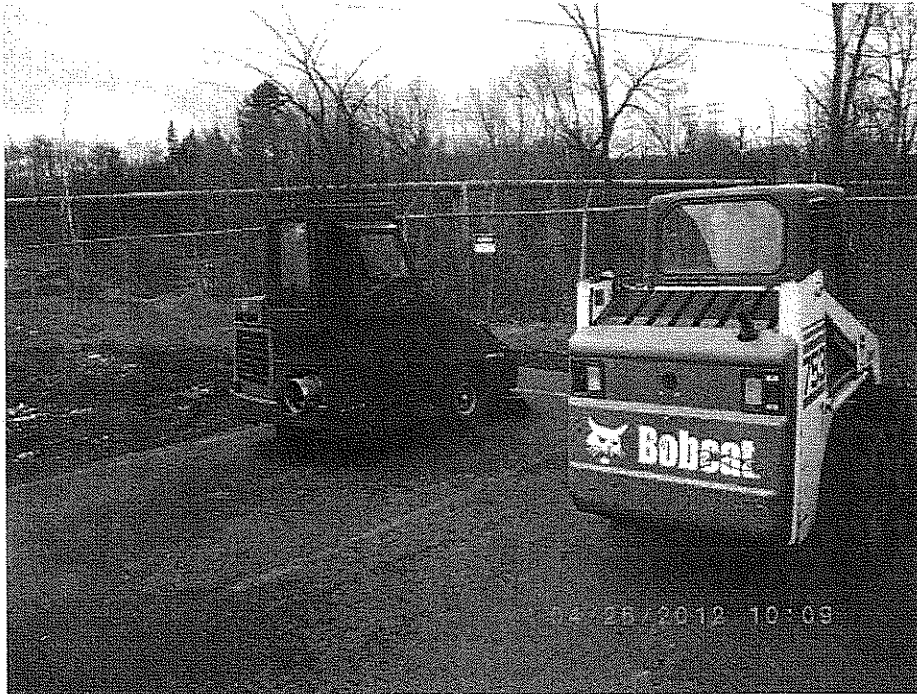
I observed that the LWEC had a small sweeper on site (Photo IMGP0941). Darryl Koski stated that the sweeper was recently purchased and that it was used for good housekeeping around JHWS including at the ash loading area.

Photo IMGP0941: Sweeper used to clean up areas of JHWS.  
Direction: Facing southwest.

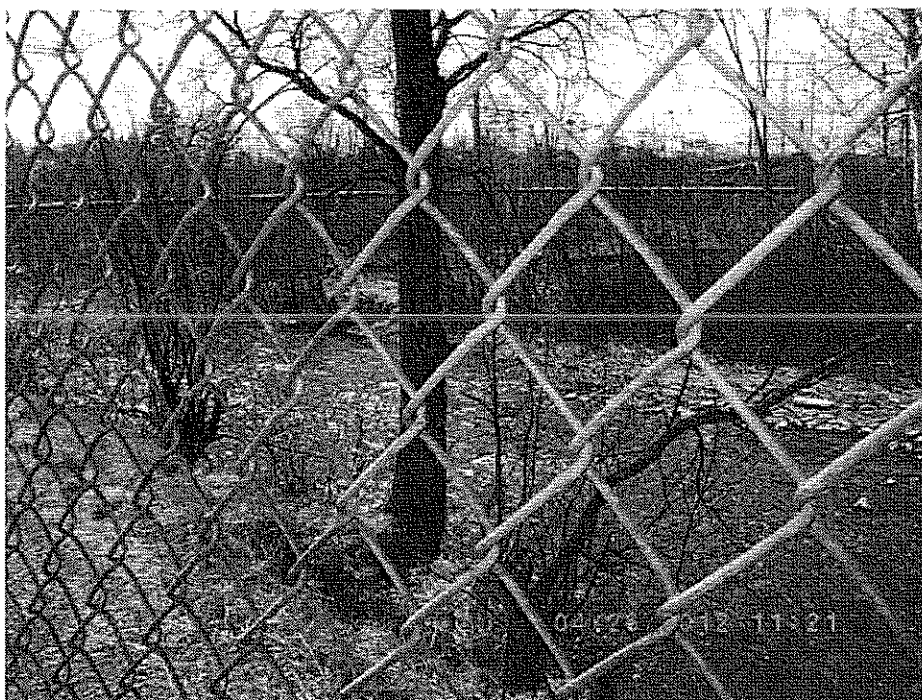
The south side of JHWS is a grassed and wooded area that sloped towards Falls River. The southwest side of the facility that borders Falls River is grassed and contains brush (Photo IMGP0970). I observed no noticeable runoff pathways from JHWS to Falls River.

Photo IMGP0970: Falls River along the southwest side of JHWS.  
Direction: Facing south.
